AIR PUBLICATION 2014A
VOLUME II

PART 3

INSTRUCTIONS FOR REPAIR

KITTY HAWK AEROPLANE

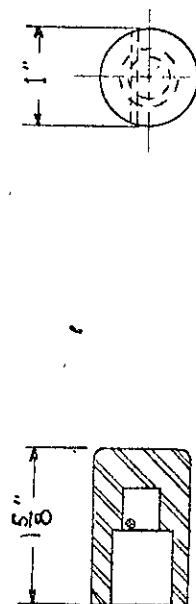
FIGURE 108 FLUSH RIVETING TOOLS

COUNTER PUNCH

TOOL NO	RIVET	A	B°
P-9333	1/8	.213	78°
P-9221	5/32	.272	78°
P-9221	3/16	.312	78°

FLUSH RIVETING TOOL - USE WITH ADAPTER

ADAPTER FOR NO 3 CHICAGO AIR GUN

ADAPTER FOR NO UU BOYER AIR GUN
